# Radio Rd Pedestrian Road Safety Audit

## Little Egg Harbor, Mercer County, NJ

### Location 1: Intersection of Radio Road and Mathistown Road to Kadlubeck Way

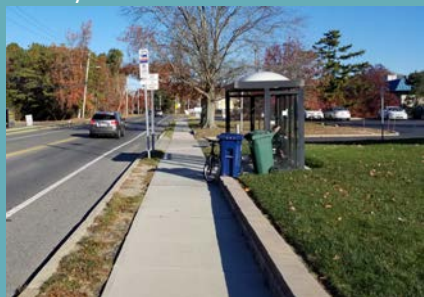
Location of NJ Transit bus stop and shelter. This is also a bus stop for OC 6, however it lacks Ocean Ride signage. Township should request that County add Ocean Ride bus stop signage.

Audit participants observed bikes locked to bus shelter. Resident audit participants confirmed that this is common and increased in summer months. Bike racks should be installed nearby.

- Connect existing segments of sidewalks on the northbound side of Radio Road
- Add Ocean Ride signage to the NJ Transit bus stop and shelter
- Install bike rack near NJ Transit bus stop and shelter

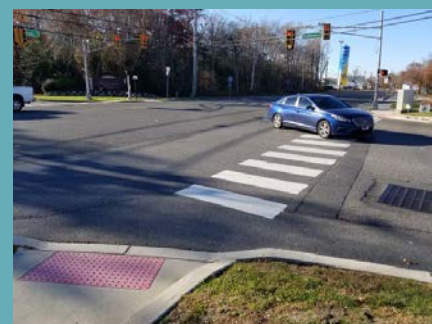
Audit participants noted that motorists traveling south on Radio Road who turned right onto Mathistown Rd did so at a high rate-of-speed and without consideration for pedestrians.

Intersection recently improved and in good condition. Actuation required to cross Radio Road. Clearance time should be increased to 3 ft per second

- Due to the proximity to senior housing and the senior center, the clearance time of crossing signals should be adjusted to meet the 3 feet per second standard for those with mobility issues

- Add Leading Pedestrian Interval (LPI) to the intersection to reduce the risk of pedestrians being struck by fast turning vehicles
- Reduce travel lanes from 12 feet to 11 feet to encourage slower driving

Consider adding leading pedestrian intervals to signal.

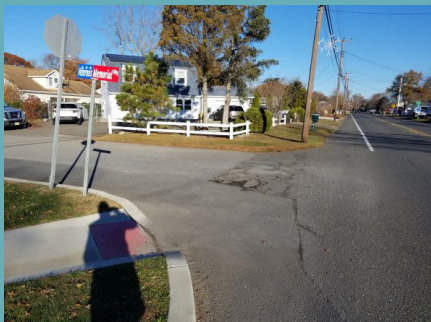
No marked crosswalks and there are large potholes that are potential hazards to pedestrians and cyclists. Add marked crosswalks and repair potholes.

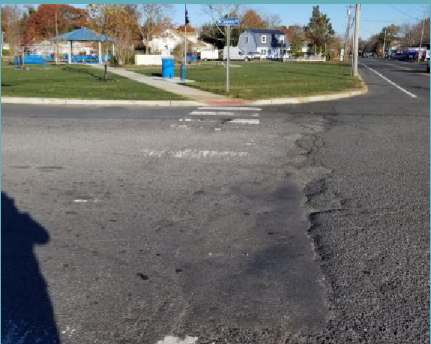
Crosswalk is faded and needs to be repainted, detectable surface covered in dirt and needs to be cleaned and/or replaced.

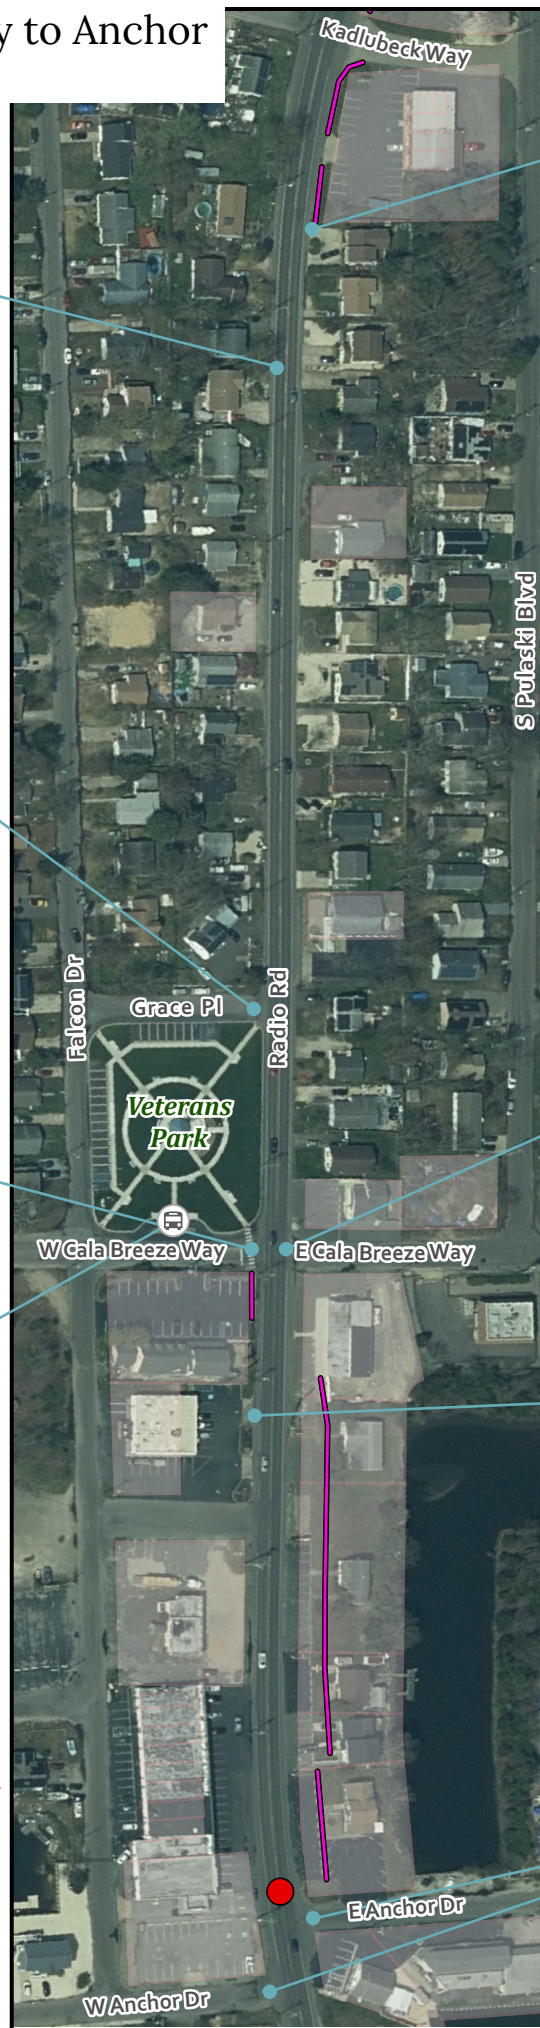
Existing sidewalk ends and is in poor condition, property owner has put up a wall on County ROW to divert foot traffic into street. Replace sidewalk, add curb cuts and remove wall.

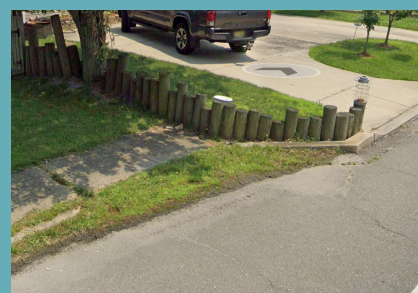
Intersection lacks marked crosswalks, add marked crosswalks.

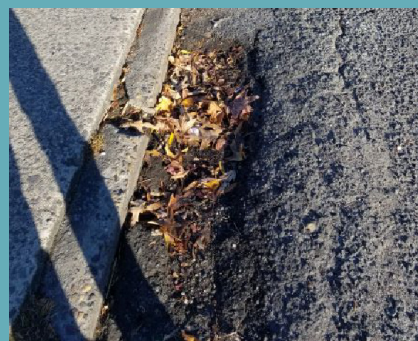
Large potholes that are potential hazards for pedestrians and cyclists. Repair potholes.

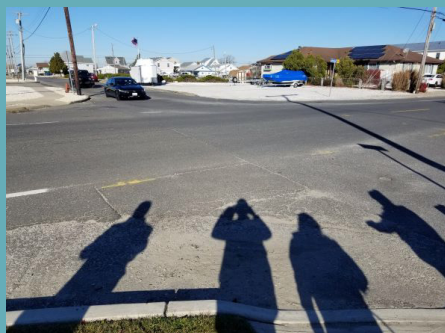
Intersection lacks crosswalks, add marked crosswalks.

Detectable surface not present at curbcut on southwest corner of intersection. Add detectable surface.

- Reduce travel lanes from 12 feet to 11 feet
- Add high visibility continental crosswalks and install detectable surfaces at the corners of Playhouse Drive and Radio Road
- Lift 25 MPH zone near Ocean Boulevard
- Maintain landscaping and prevent obstructing road users
- Connect and expand existing sidewalks near Graveling Point Beach
- Install bike parking in the Graveling Point Beach parking area
- Continue bike lanes and parking prohibition until Surfside Boulevard near Graveling Point Beach (See Appendix C for examples)

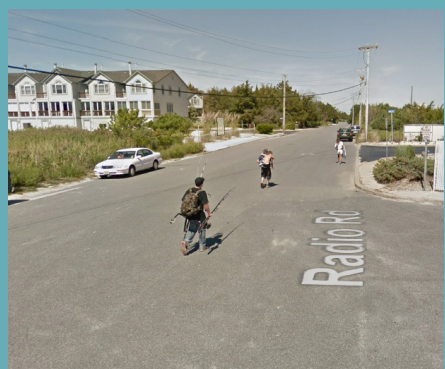
Location of beach expansion project, which may result in an increase of beach visitors. Add sidewalks to west side of Radio Road from Surfside Boulevard to Graveling Point Beach. This will allow for safe travel of beach visitors who need to park farther away due to increased demand.

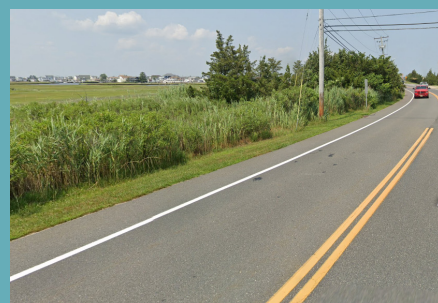
This area of Radio Road was identified as potentially dangerous due to the small shoulder near a bend in the road. Audit participants were concerned that pedestrians on the southbound side were at a high risk of being struck or forced off the road into the adjacent wetlands.

Expand shoulder to give more space for pedestrians and cyclists. Consider adding sidewalks to this area.
